Claus Johannsen, Seokryung Yoon, Jonathan Baré

## Introduction

The RN19 IMS station on Easter Island, Chile is equipped with a SAUNA xenon sampling system to monitor worldwide compliance with the CTBT. This SAUNA system had severe equipment failure shortly before the COVID-19 lockdown in 2020. Consequently, the system could not sample and measure Xenon.

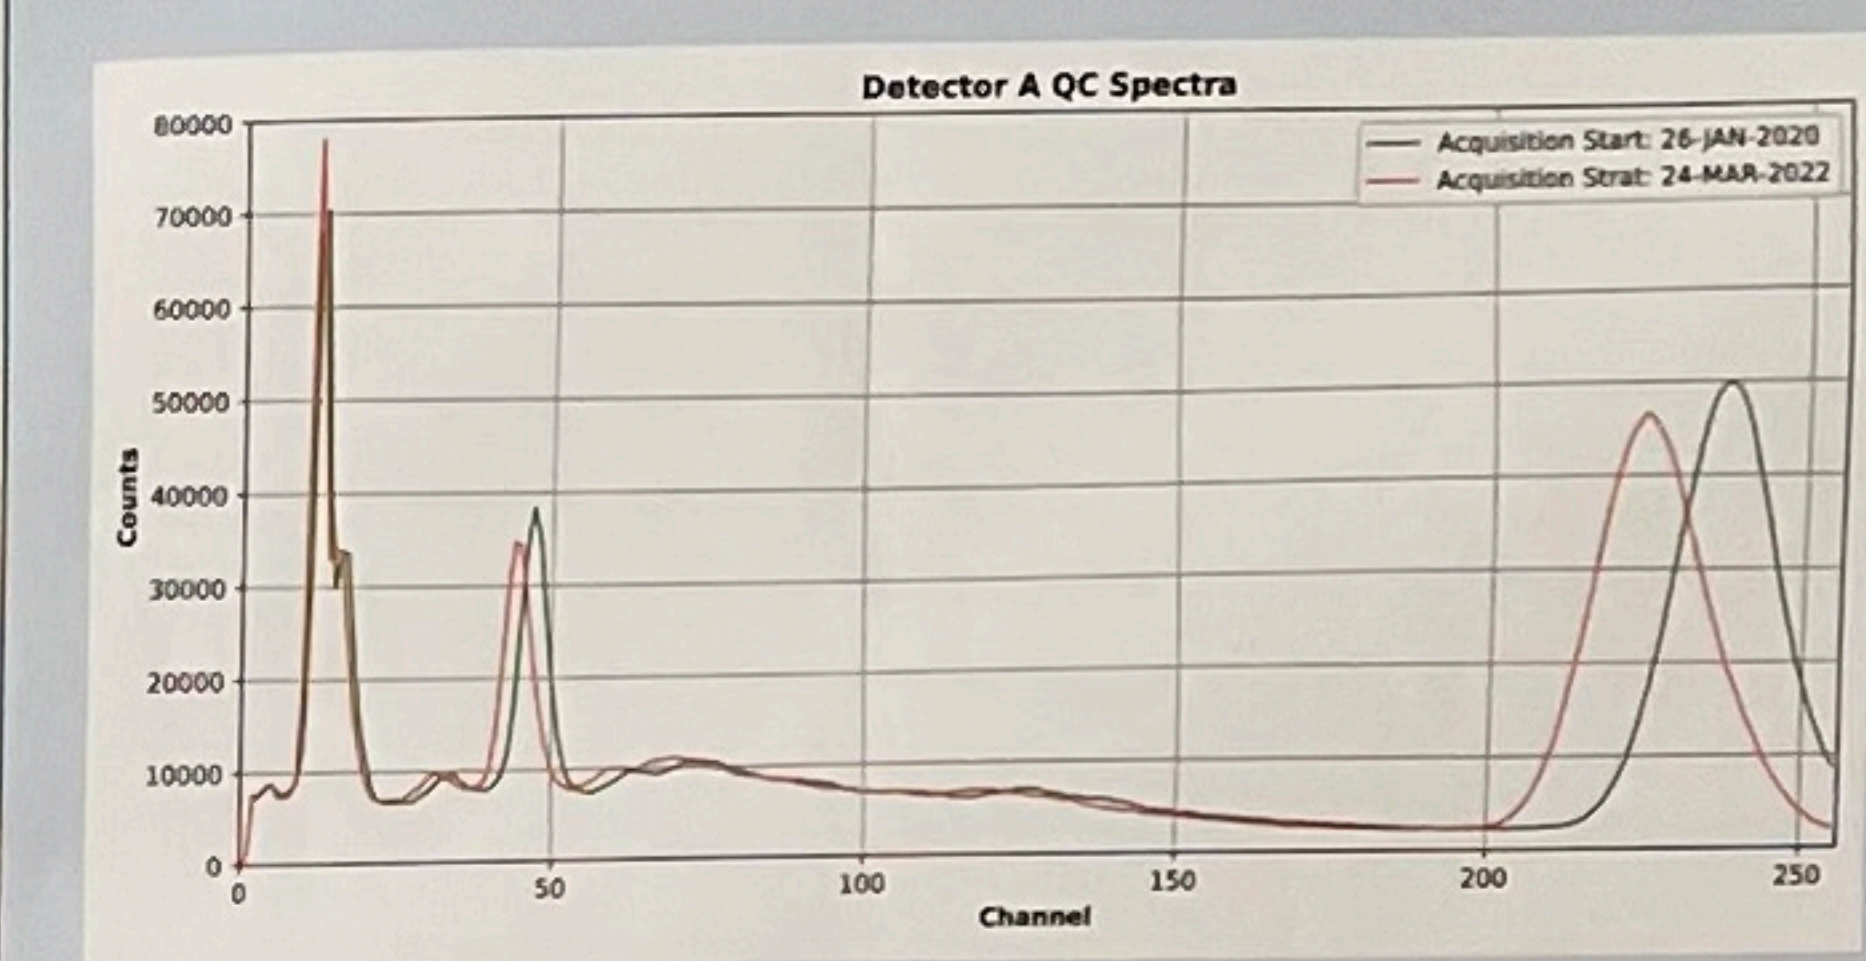
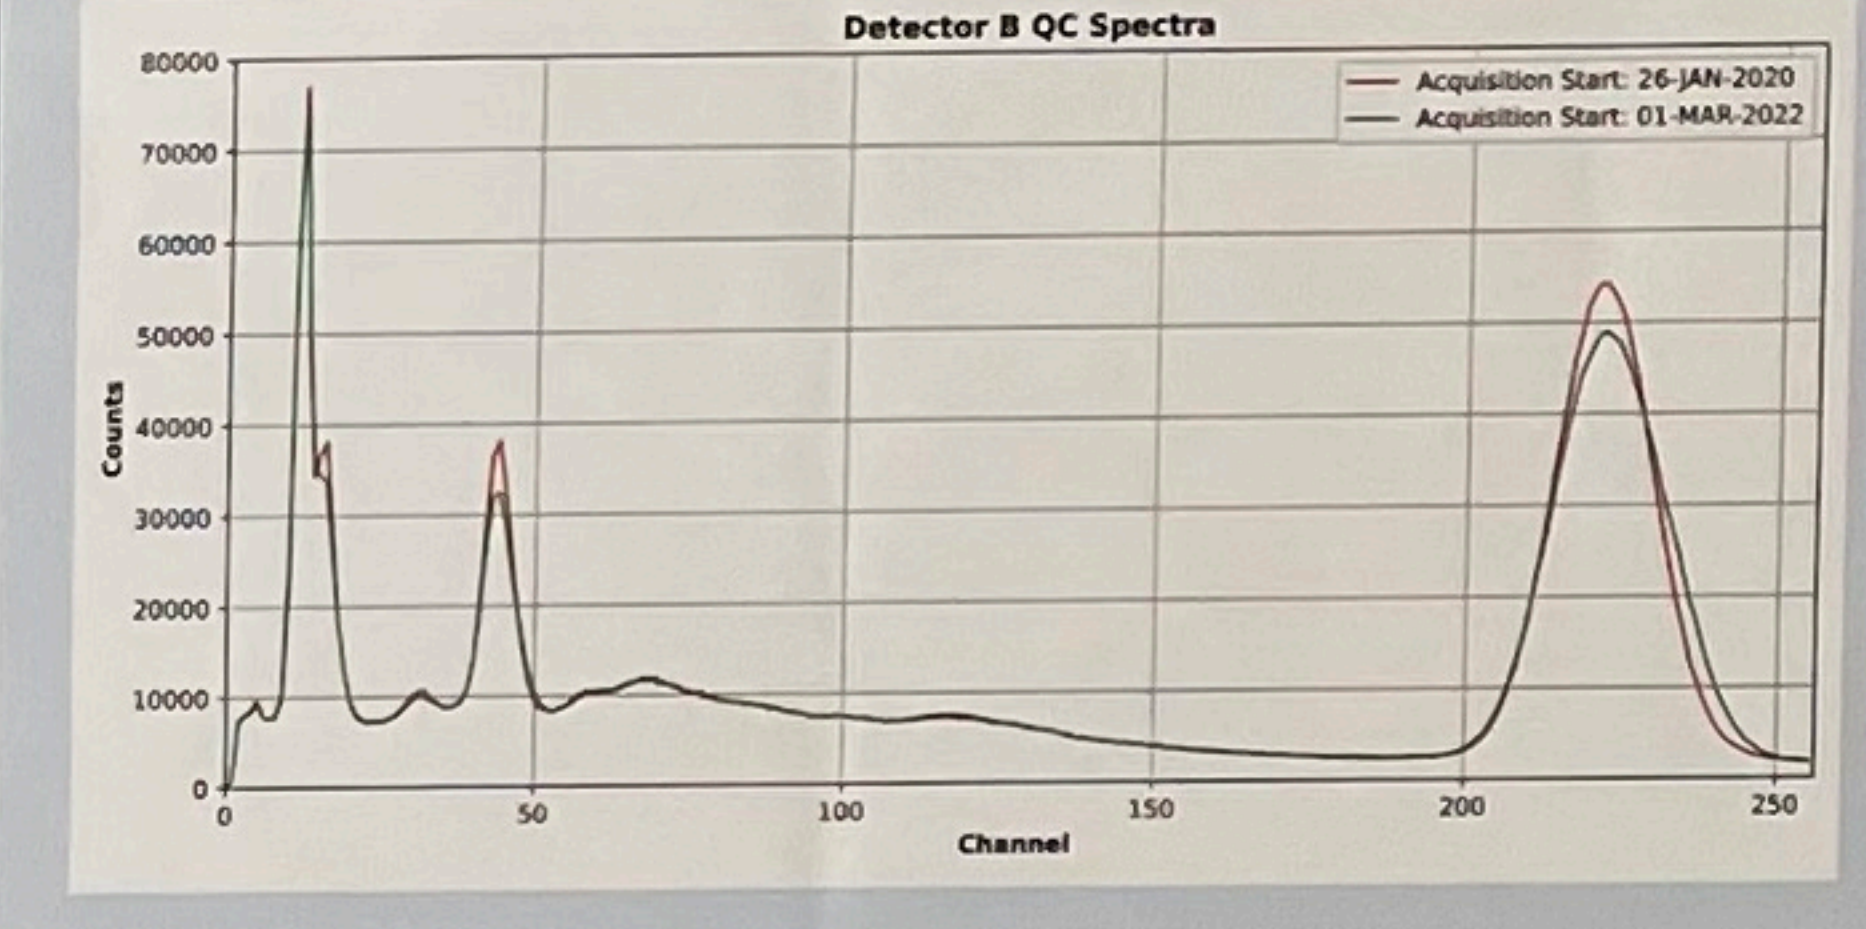
Without proper maintenance, the system was down for two years due to multiple issues in the system. Detector performance had to be evaluated before restoring the system back to normal operation. The evaluation process was challenging because adequate spectra were not available.

SAUNA II systems have QC sources for detector quality control, but it was noted that the geometry of the QC measurement had changed due to faulty QC source feeder, thus it was not a simple task to examine detector efficiency drops.

After in-depth discussions, it was concluded that gain drift, peak resolution and tailings could be investigated as a partial verification approach to confirm the integrity of detectors and electronics.

QC spectra from before and after the system-down were compared. The SAUNA QC source mix consists of Cs-137 and Eu-154. For gamma detectors, gamma peaks at 123.1 keV and 661.7 keV were investigated.
